Logan Inspection Services

Inspection Report

1234 Anywhere Street
Birmingham, AL 35222

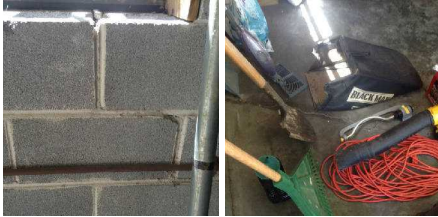
- 1. Structure Type: Wood frame
- 2. Foundation: Block
- 3. Differential Movement: Crack with displacement - [Cracks with displacement. A structural engineer is recommended to evaluate and estimate repairs](#)

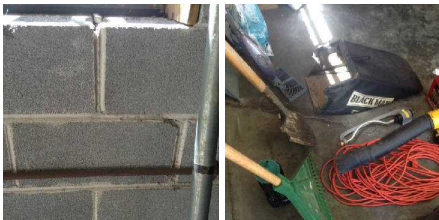
12. Differential Movement: Crack with displacement - [Cracks with displacement.](#) [A structural engineer is recommended to evaluate and estimate repairs](#)
